# Geologic Assessment

U.S. Highway 290 (US 290) / State Highway (SH)  
71 West from State Loop 1 (MoPac) to  
Ranch-to-Market (RM) 1826 and SH 71 to  
Silvermine Drive  
Travis County, Texas  
CSJ: 0113-08-060 and 0700-03-077

December 2016; Revised November 2017, August 2018, April 2019

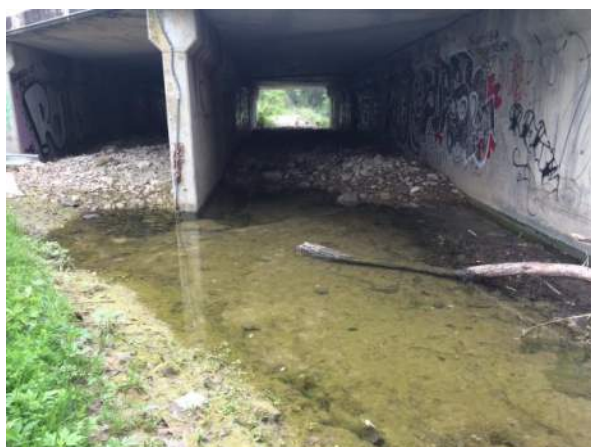
Feature F-1 is a group of widely spaced fractures within the Williamson Creek streambed located just upstream of US290. The orientation of the fractures, N34°E, suggests they may be related to displacement along the Mount Bonnell Fault, which is located a few hundred feet to the northwest. However, these fractures do not appear to be able to convey a significant amount of recharge into the subsurface because fracture apertures are less than one-tenth of one inch and the opposing sides are similar in shape. This suggests that enlargement through dissolution has occurred. As such, there is limited likelihood that recharge occurs through this feature.

Feature F-1. Widely spaced fractures within the Williamson Creek streambed located just upstream of US290

Because of the correspondence of the orientation of these fractures with the orientation of Mount Bonnell Fault, the feature could have a connection to a deeper karst feature in the subsurface. Appropriate precautions should be considered in planning for construction and during construction.

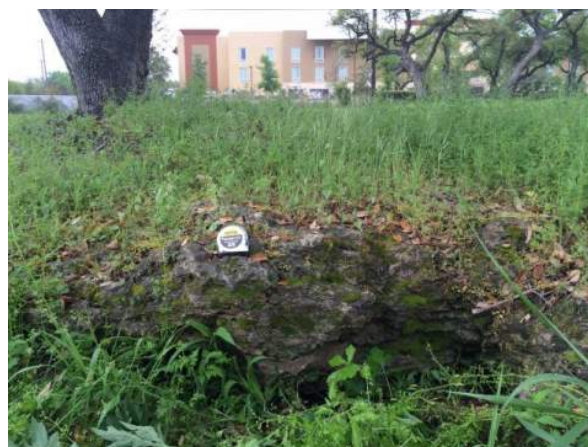
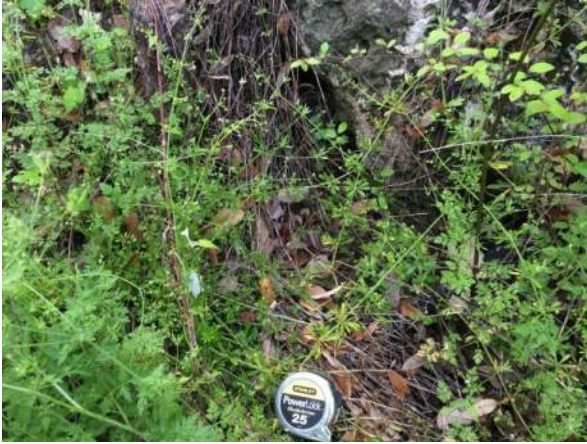
Feature F-2 is a solution cavity situated along the base of a bedding outcrop. The extent of the feature is limited due to infilling by soil and organic debris and animal burrowing is evident. The potential for rapid infiltration is low and the feature was evaluated as non-sensitive.

Feature F-2 solution cavity situated along the base of a bedding outcrop

Feature F-2 zoom-in of solution cavity situated along the base of a bedding outcrop

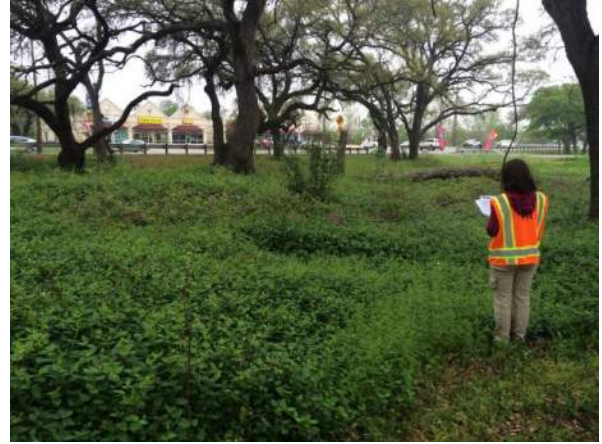
appear to cover most of the area. These factors limit infiltration while supporting rapid runoff. The feature was evaluated as non-sensitive with a low relative potential for infiltration.

Feature F-3 small outcrop of limestone on the south side of US290 exhibiting small interconnected solution enlarged cavities (Depression, veg cover)

This feature likely does not exhibit high infiltration and recharge to the subsurface. Appropriate precautions should be considered in planning for construction and during construction.

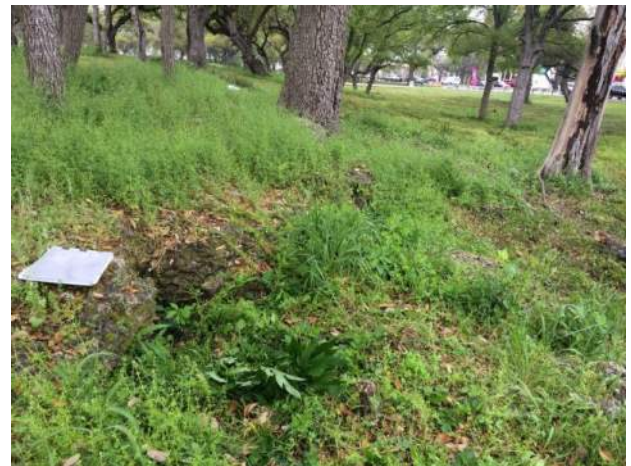
Feature F-4 is zone of fractures located south of US290 along the southern margin of the TxDOT right-of-way. The feature encompasses an approximately 100-ft by 30-ft area on a gently sloping hillside covered with live oak trees and Ashe juniper (locally referred to as cedar). Multiple fractures are present, and apertures appear to show some evidence of solution enlargement although most are infilled with vegetation and soil. While there are slight variations, the average trend of the fractures is about N20°E, which is consistent with the regional structural trend. This suggests the fractures may be related to displacement along the Mount Bonnell Fault to the northwest. The outcrop in which the fractures are present also shows some honeycomb texture that supports the possibility of recharge enhancement through solution enlargement. However, the large amount of vegetative debris filling the fractures, coupled with the Speck soils that are characterized by high runoff potential and occur across this portion of the study area, suggest a rapid runoff potential in lieu of infiltration. Overall, the feature is expected to have a low potential for recharge to the aquifer. However, due to the zone classification of the feature and similarity with the regional structural trend, the feature was evaluated as sensitive.

Feature F-4. Zone of fractures located south of US290 along the southern margin of the TxDOT right-of-way

Feature F-4. Zone of fractures looking to the east.

This feature contains a zone of fractures coincident with the regional structural trend and could have a connection to a deeper karst feature in the subsurface that contributes greater than average recharge to the Edwards Aquifer. Appropriate precautions should be considered in planning for construction and during construction.

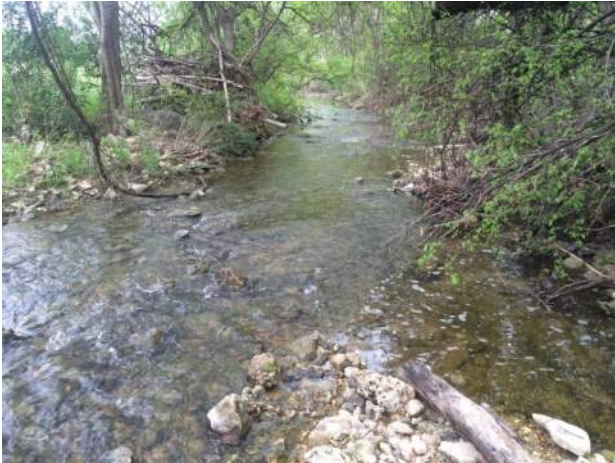
Where exposed within Williamson Creek, the Mount Bonnell Fault shows little evidence of solution enlargement. The location of the feature is based upon nearby fractures and changes in lithology on opposing sides of the fault. The fault juxtaposes the Glen Rose Limestone to the northwest against Edwards Limestone. Most fractures within the streambed appear to be sealed with fine grained sediment and vegetative debris. This feature is not exposed in any other location within the project area. It was evaluated as sensitive with a moderate potential for infiltration.

Feature F-5. Surface expression of the Mount Bonnell Fault within Williamson Creek.

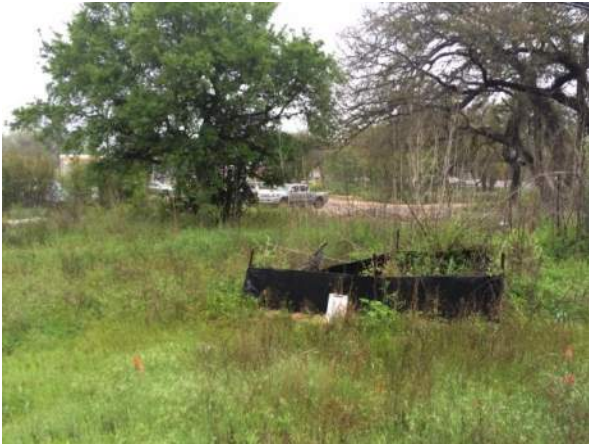
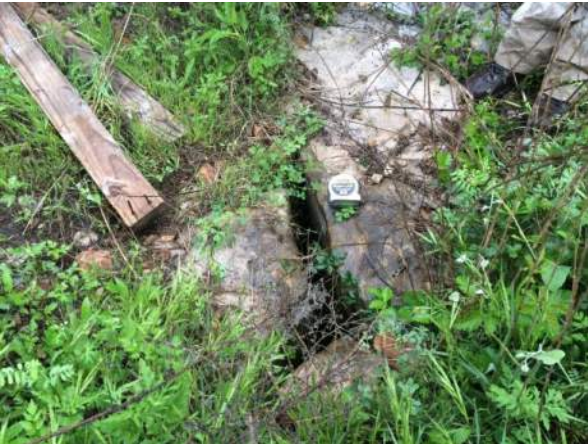
Feature F-6 – solution cavity located along the southern limits of the TxDOT right-of-way south of US290.

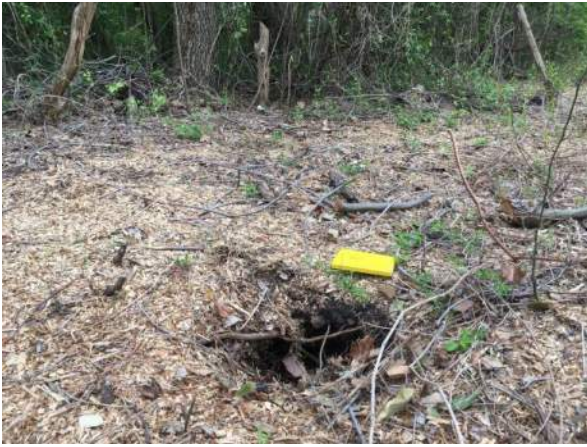
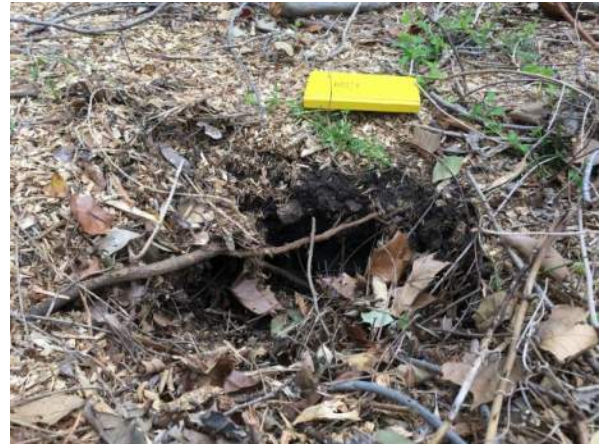
Feature F-7 – Cavity located north of the existing US 290 right-of-way along the transmission line corridor.

This feature likely does not exhibit high infiltration and recharge to the subsurface. Appropriate precautions should be considered in planning for construction and during construction.

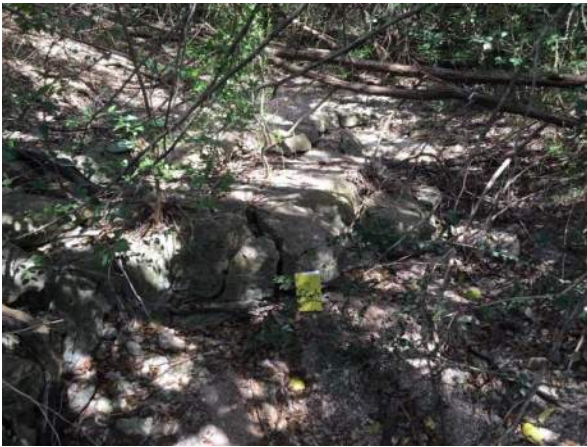
Feature F-8 includes a zone of fractures area of horizontal bedding in a hillside drainage. The feature is located south of the intersection of Old Bee Caves Road and the Bell Hill Country Apartments exit road on the proposed right-of-way. The area of surface enlarged fractures in limestone has apertures between 1-3 centimeters. The features were evaluated as non-sensitive with a low relative potential for infiltration.

Feature F-8 – Area of fractures located south of the intersection of Old Bee Caves Road and the Bell Hill Country Apartments entrance road. On proposed right-of-way.

This feature likely does not exhibit high infiltration and recharge to the subsurface. Appropriate precautions should be considered in planning for and during construction.

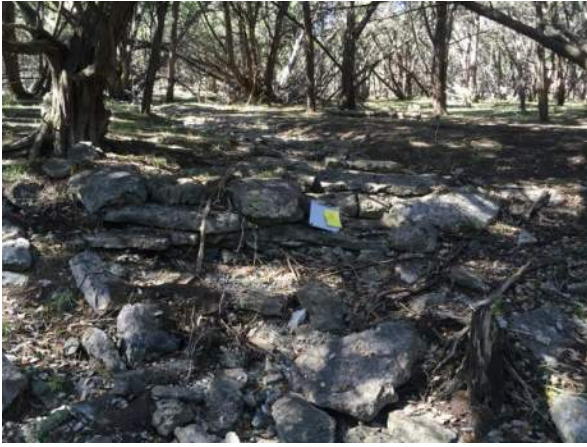
Feature F-9, an area of horizontal fractures, is located on a hillside drainage within proposed right-of-way for the detention pond on the southwest side of SH 71. This zone of surface enlarged fractures in limestone had apertures between 1-2 centimeters. The feature is evaluated as non-sensitive with a low relative potential for infiltration.

Feature F-9 – Area of fractures located within proposed right-of-way for the detention pond on the southwest side of SH 71.

This feature likely does not exhibit high infiltration and recharge to the subsurface. Appropriate precautions should be considered in planning for and during construction.

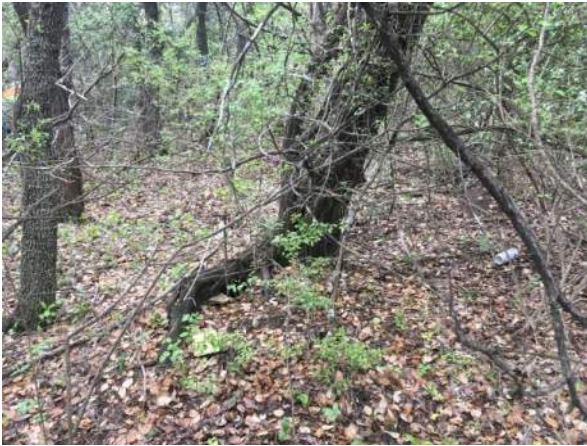
Feature F-10 is a cavity, over 3 feet deep, at the base of an Ashe juniper (The tree is marked with a tag #1591.) root. The cavity is in soil and most likely originated from animal activity. The feature has been marked with white flagging tape and is located south of US290 and east of RM 1826 within existing right-of-way. The feature was evaluated as non-sensitive with a low relative potential for infiltration.

Feature F-10 – Hole (possibly and animal hole) at the base of a tree. Located within the existing right-of-way south of US290 and east of RM 1826.

This feature likely does not exhibit high infiltration and recharge to the subsurface. Appropriate precautions should be considered in planning for and during construction.

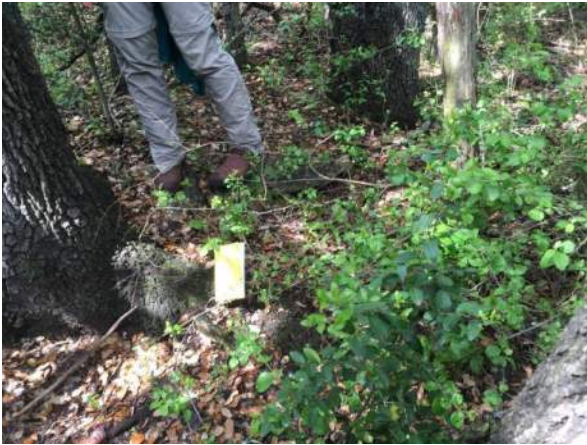
Feature F-11 is an enlarged fracture on a small slope. The feature is located south of US290 and east of RM 1826 within existing right-of-way. Feature F-11 is within a wooded area and consists of a bench with weaker rock underneath the bench. The feature is between tagged trees with marker numbers: 2380, 2828, 2378 and 1579. The feature was evaluated as non-sensitive with a low relative potential for infiltration.

Feature F-11 – Enlarged fracture, which consisted of a rock bench with a weaker area underneath. This feature was located south of US290 and east of RM 1826.

This feature likely does not exhibit high infiltration and recharge to the subsurface. Appropriate precautions should be considered in planning for and during construction.

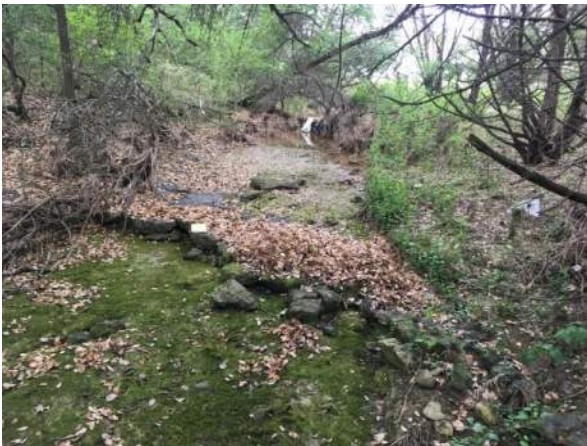
Feature F-12 is a solution enlarged fracture in a streambed. The feature is located south of US290 and east of RM 1826, downstream of a large culvert. The feature is located within existing right-of-way and within the ordinary high water mark of the drainage. The feature had a drainage area greater than 6 acres and was evaluated as sensitive with a moderate potential for infiltration.

Feature F-12 – A solution enlarged fracture in a streambed. Feature F-12 is located within existing right-of-way south of US290 and east of RM 1826.

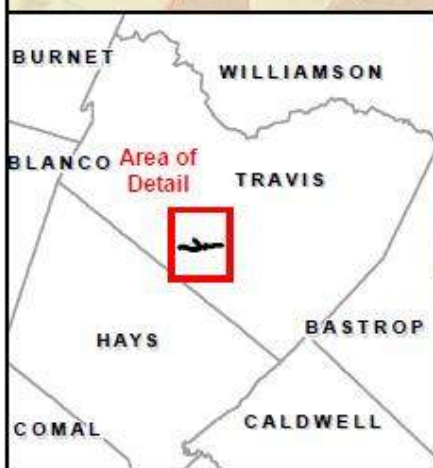
**Figure 2a. Geologic Features Map**  
 Oak Hill Parkway: US 290W from Mopac/Loop1 to west of Circle Drive and SH 71 from US 290W to Silvermine Drive

A search of the TWDB Groundwater Database (GWDB) Record of Wells Report for Travis County was completed (TWDB, 2016). Several wells are located near the project area but none are located within the survey area defined as the existing TxDOT ROW and proposed ROW. One well in the TWDB database was identified within 50 ft of the survey area, TWDB Well #5849310. The TWDB GWDB information on this well indicates that it was completed in 1962 in the Upper Member of Glen Rose Limestone and is currently unused. The well was not located during the survey. The well's location according to the TWDB GWDB is shown on page one of eight of **Figure 2**.
