Oak Hill Parkway  
Water Resources  
Technical Report  
ADDENDUM

OAK HILL  
P A R K W A Y

U.S. Highway 290 (US 290) / State  
Highway (SH) 71 West from State Loop 1 (Mopac)  
to West of Ranch-to-Market (RM) 1826 and US  
290 to Silvermine Drive

May 2019

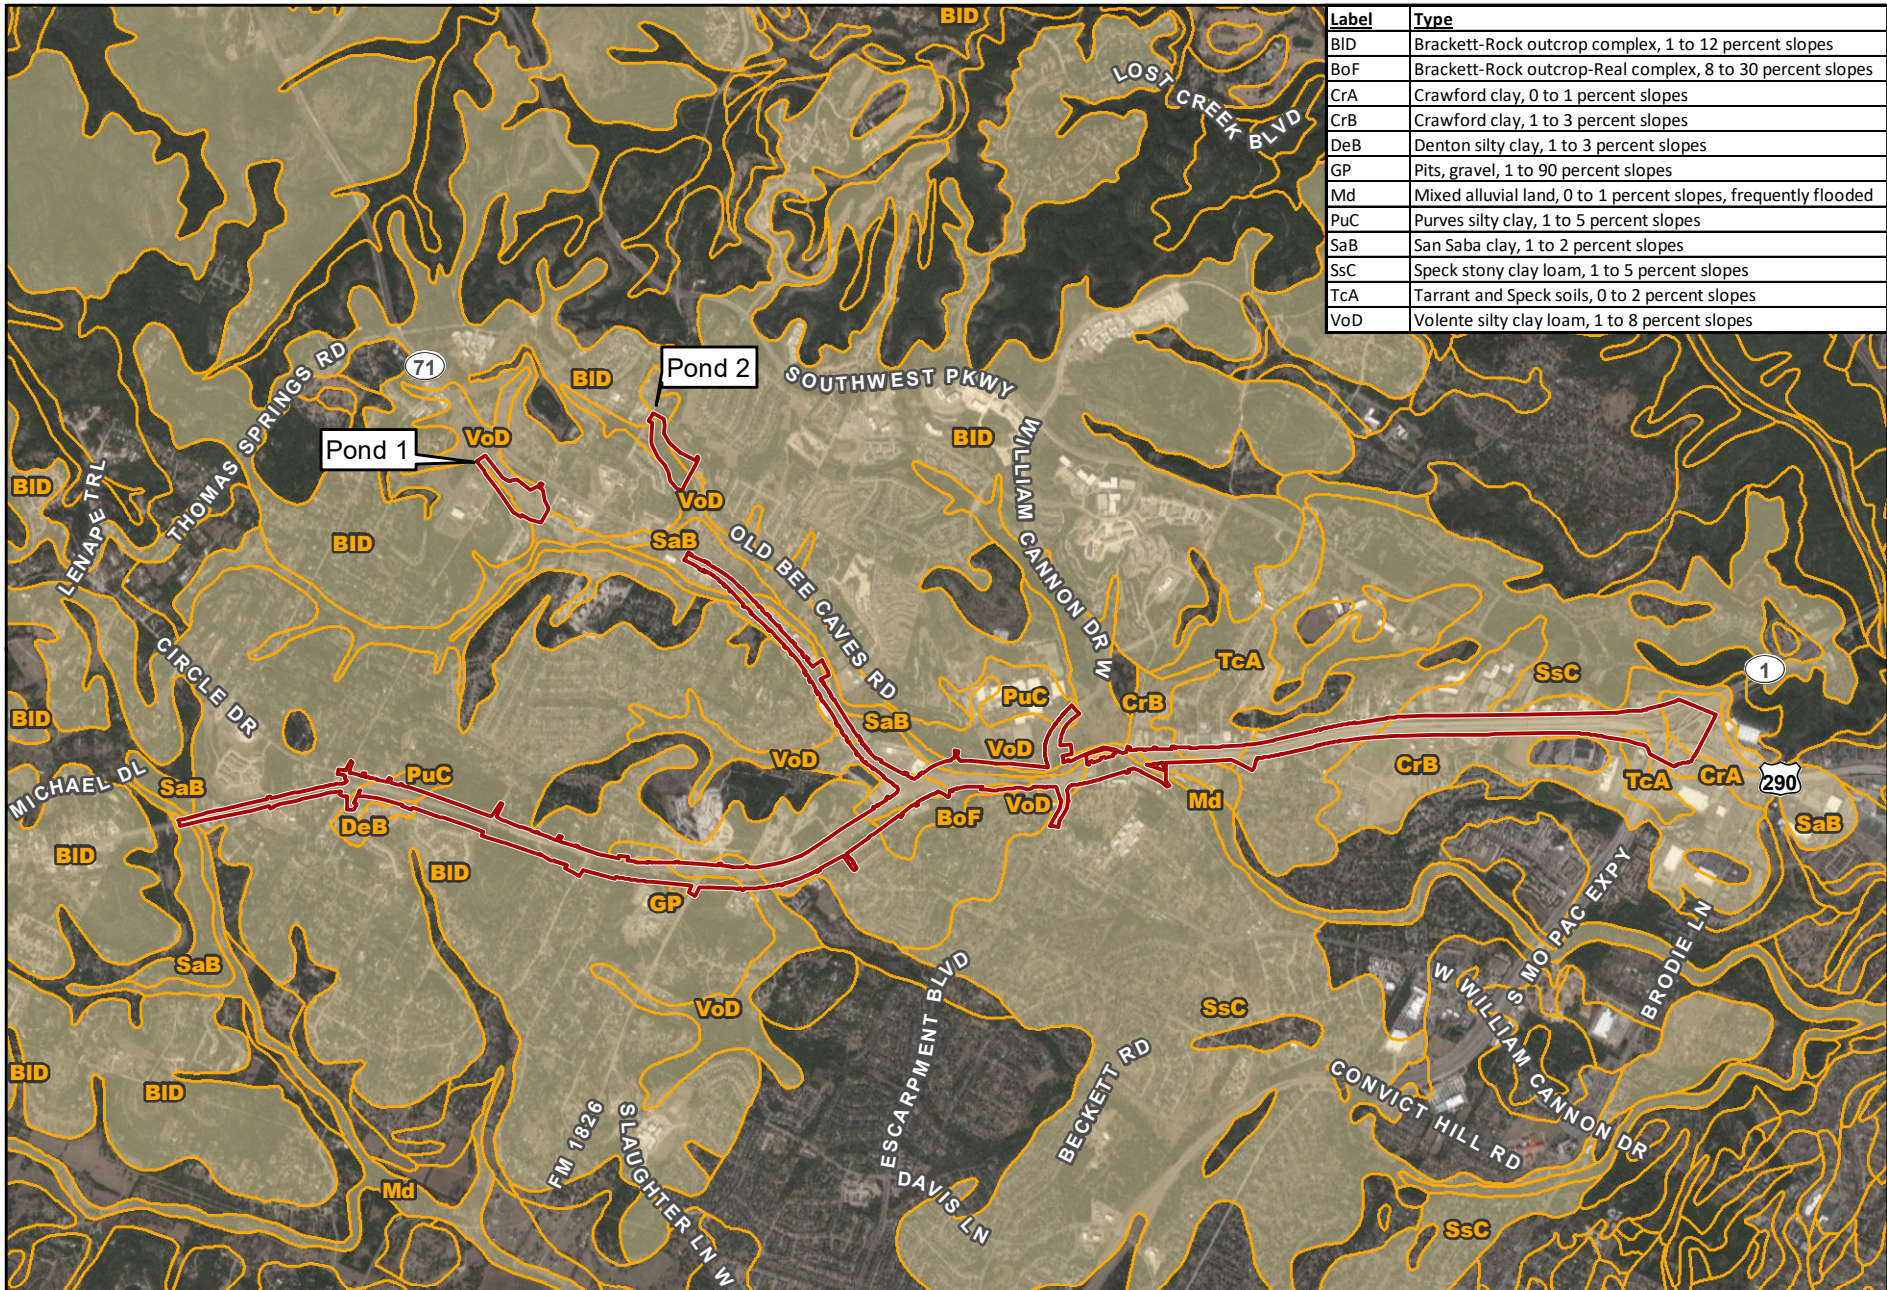
**Figure 4. Project Area Soils**

Label	Type
BID	Brackett-Rock outcrop complex, 1 to 12 percent slopes
BoF	Brackett-Rock outcrop-Real complex, 8 to 30 percent slopes
CrA	Crawford clay, 0 to 1 percent slopes
CrB	Crawford clay, 1 to 3 percent slopes
DeB	Denton silty clay, 1 to 3 percent slopes
GP	Pits, gravel, 1 to 90 percent slopes
Md	Mixed alluvial land, 0 to 1 percent slopes, frequently flooded
PuC	Purves silty clay, 1 to 5 percent slopes
SaB	San Saba clay, 1 to 2 percent slopes
SsC	Speck stony clay loam, 1 to 5 percent slopes
TcA	Tarrant and Speck soils, 0 to 2 percent slopes
VoD	Volente silty clay loam, 1 to 8 percent slopes

Information regarding soils within the project corridor was obtained from the U.S. Department of Agriculture NRCS Soil Surveys for Travis County (NRCS, 2018) (**Figure 4**). Twelve soil series are located in the project area and have a range of slopes and infiltration characteristics. No soils within the project area are mapped as hydric or containing hydric inclusions. A list of soils occurring within the project area is included as **Table 1**.

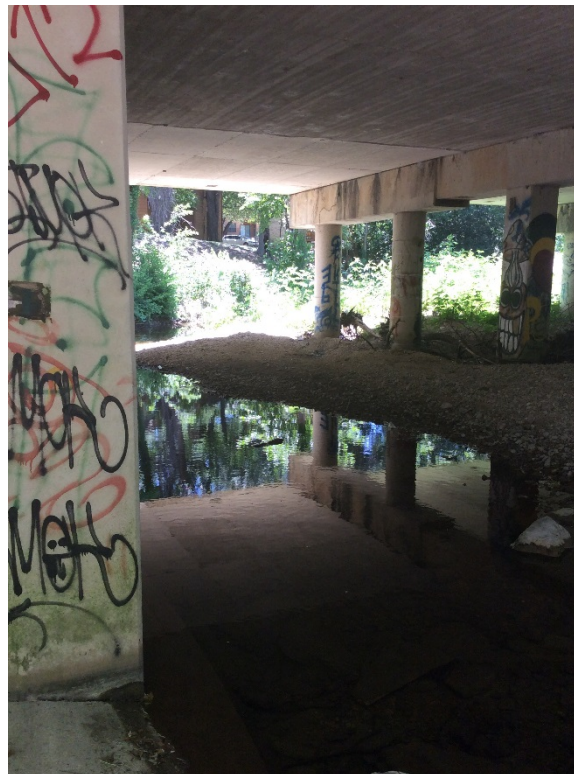
**Photograph 24:** S-5 under SH 71 looking west

- Williamson Creek (S-5 and S-6) is an intermittent stream with a variable width OHWM of 5 to 25-feet within the project area (**Figure 6a-d, 6k, and Photos 24-32**). S-5 was identified as the headwaters of Williamson Creek and exhibited flow with perennial pools observed at the time of the delineation in 2019. S-6 was identified as the main branch of Williamson Creek. Williamson Creek originates northwest of the project area and flows to the southeast along US 290/SH 71 into Onion Creek and on to the Colorado River. Williamson Creek is located within the 100-year FEMA designated floodplain.

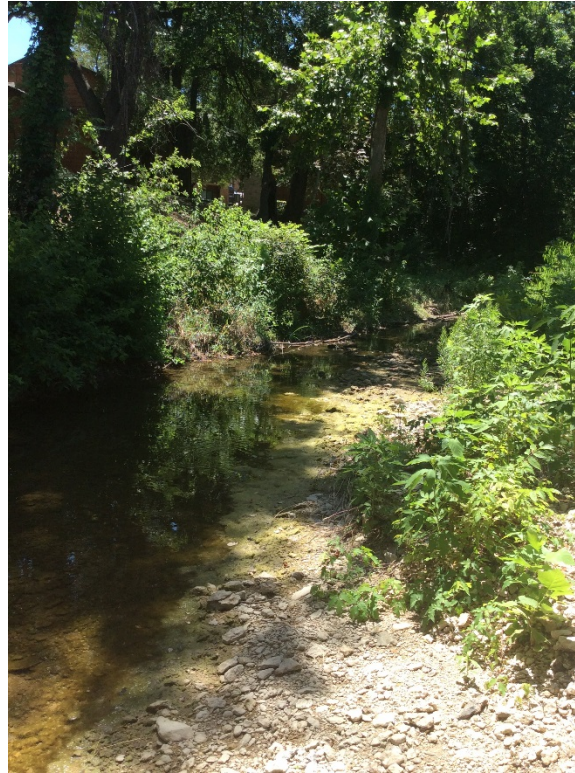
**Photograph 25:** S-5 looking east

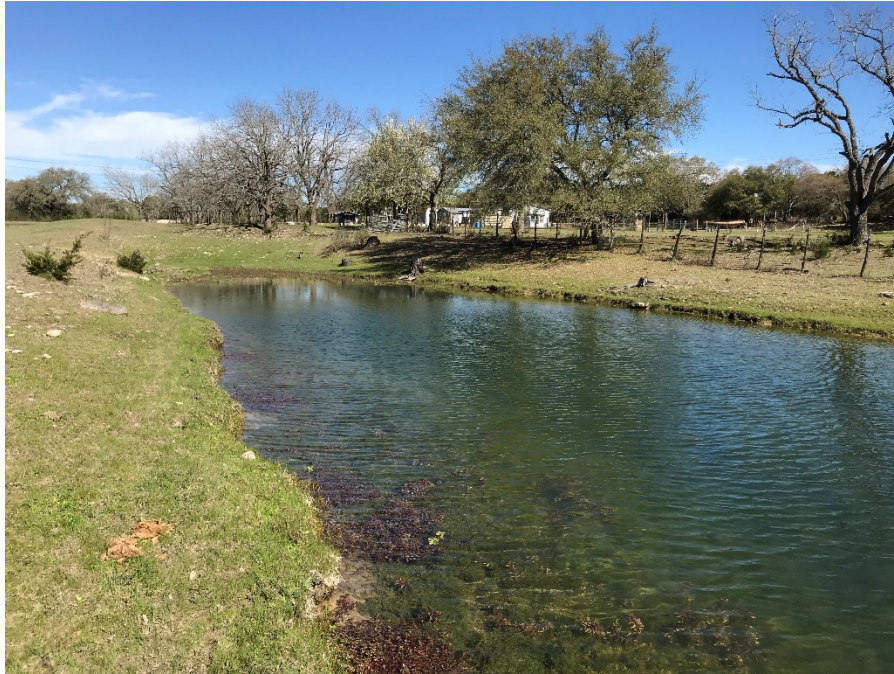
**Photograph 41:** Excavated on-channel stock pond (Open Water 1) located within SH 71 detention pond; facing north.

- Open Water 1 and Open Water 2 are on-channel impoundments of S-11 (unnamed tributary to Williamson Creek) and would be best described as excavated stock ponds (**Photos 41-42**). Standing water, approximately 5 inches to more than 36 inches deep, was observed within both of these features during the field investigations.

These features would likely be classified as “deep water habitat” and do not qualify as wetlands, since one or more of the three necessary wetland indicators (wetland hydrology, hydrophytic vegetation, and hydric soil conditions) are missing. Due to their hydrologic connection to Williamson Creek, these open water ponds would likely be considered jurisdictional features.

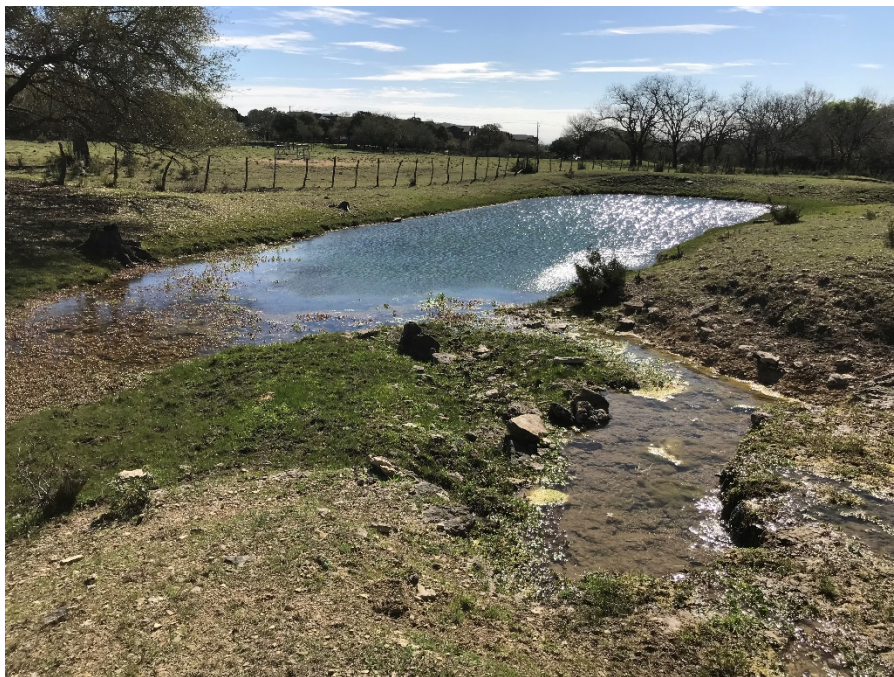
**Photograph 42:** Excavated on-channel stock pond (Open Water 2) within SH 71 detention pond; facing southwest.

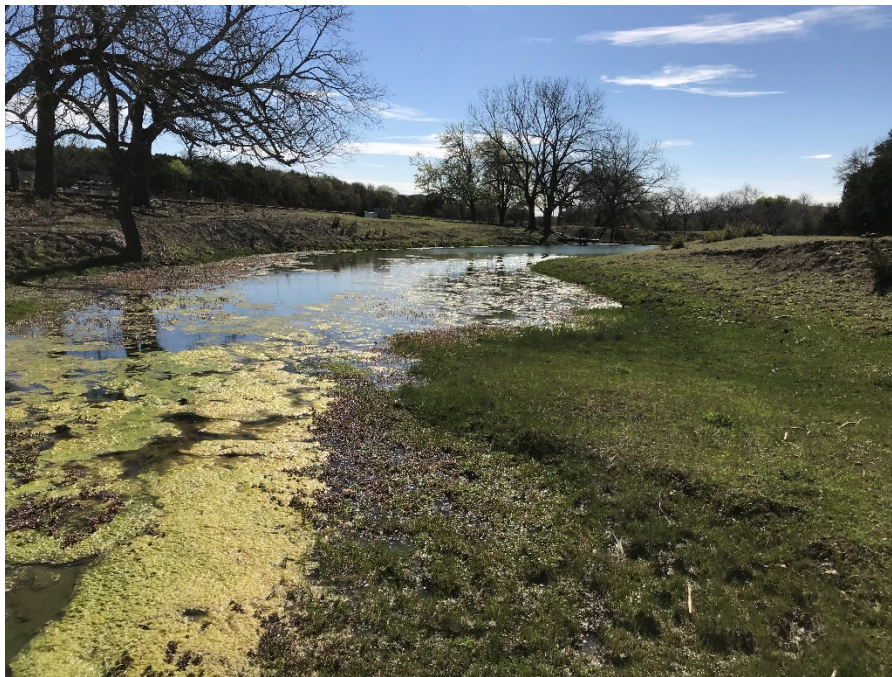
**Photograph 44:** Wetland (Wetland 2) within the SH 71 detention pond; facing south.

Wetland 2 was not identified in the 2018 Final EIS/ROD as an aquatic feature within the project area, however, it was delineated within the SH 71 proposed detention pond site in 2019 (**Figure 5b**, **Figure 6m**, and **Photo 44**). This wetland was not identified on the NWI and is not located within a floodplain. This small emergent wetland was located adjacent to the S-11 (unnamed tributary to Williamson Creek) stream channel. Two inches of standing water was observed within the wetland during the field investigation. Due to its hydrologic connection to a likely jurisdictional stream (S-11), Wetland 2 is a potentially jurisdictional wetland.
