Oak Hill Parkway
Water Resources
Technical Report
ADDENDUM #2

U.S. Highway 290 (US 290) / State
Highway (SH) 71 West from State Loop 1 (Mopac)
to West of Ranch-to-Market (RM) 1826 and US
290 to Silvermine Drive

Travis County, Texas

November 2019

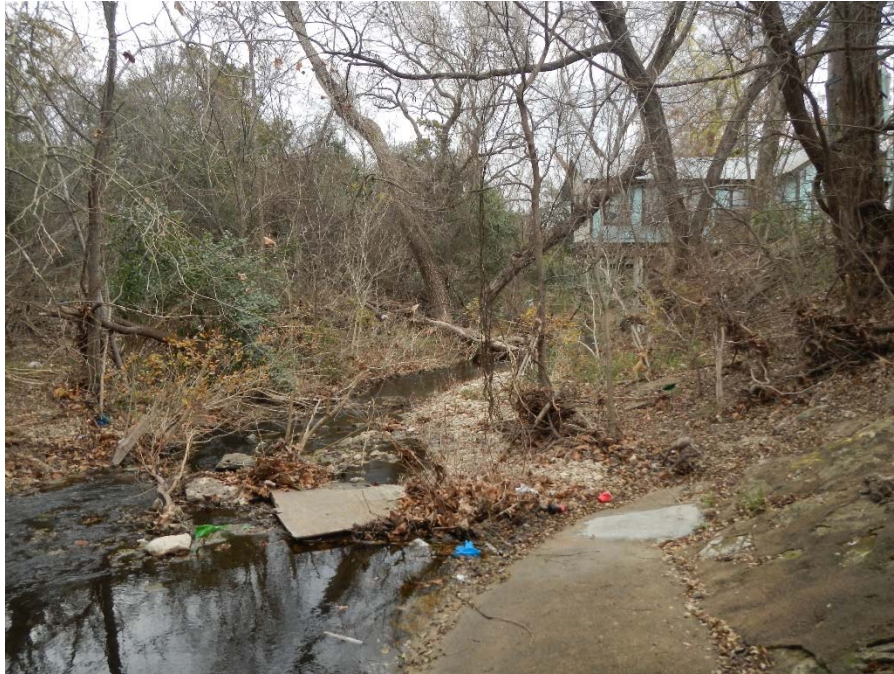
Photograph 9: Riparian vegetation at SH 71 Williamson Creek crossing (S-5); facing southeast.

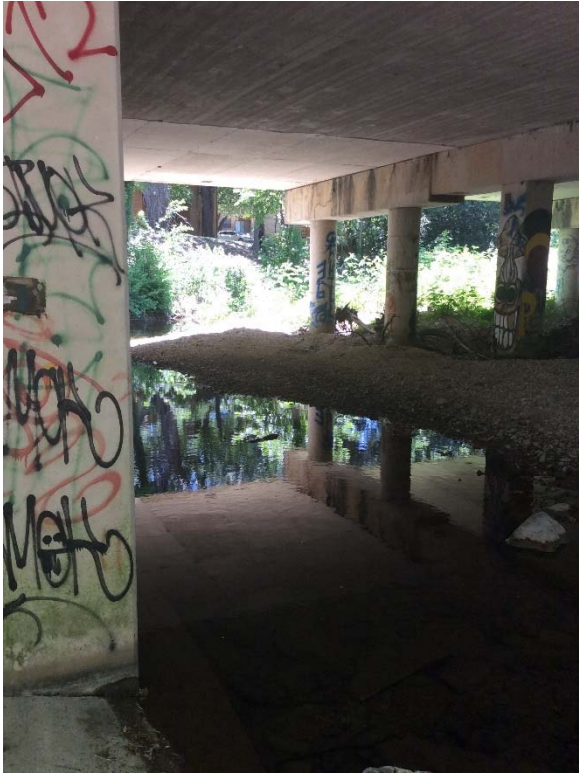
Photograph 21: S-5 under SH 71 looking west

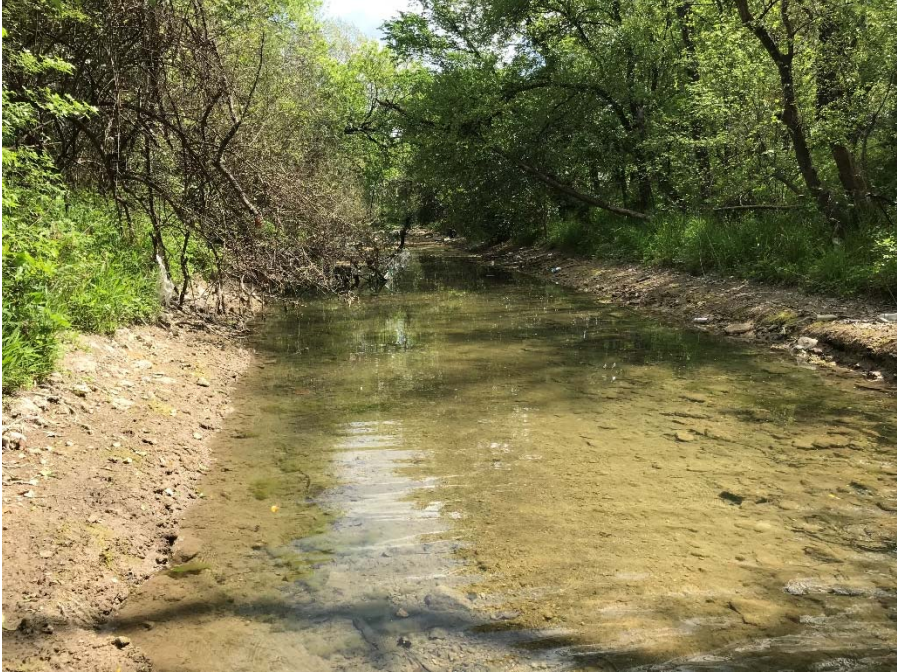
Photograph 25: Perennial pool areas along S-6, Williamson Creek east of William Cannon; viewing east.

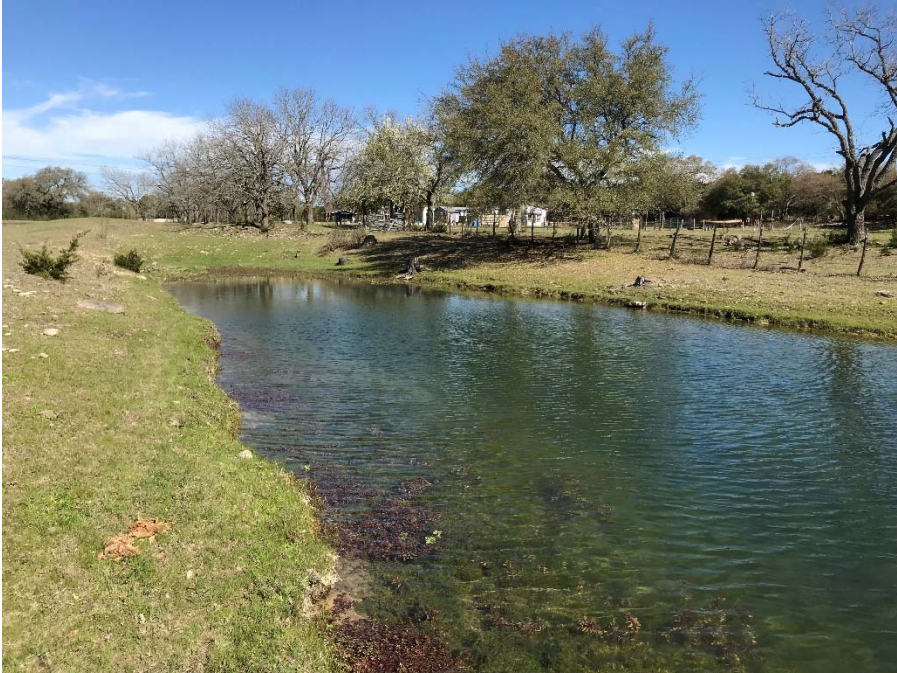
Photograph 38: Excavated on-channel stock pond (Open Water 1) (no longer in the project area) located within SH 71 detention pond; facing north.

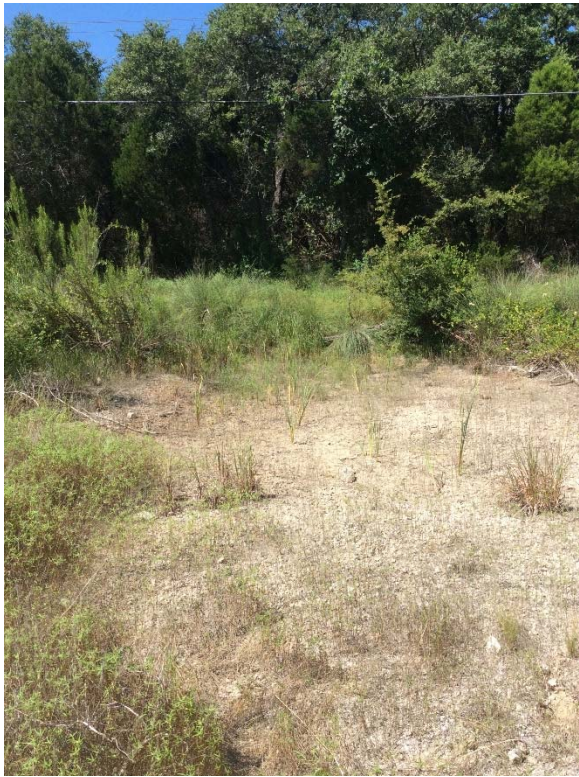
Photograph 40: Wetland (Wetland 1) near Boling Drive, within the project area; facing south.

The acreage of impacts of each potentially jurisdictional water body within the existing and proposed right-of-way, along with the total project area acreages, are shown in **Table 1** below. Field data sheets are included in **Attachment C** for the wetland location.
