Geologic Assessment

U.S. Highway 290 (US 290) / State Highway (SH)
71 West from State Loop 1 (MoPac) to
Ranch-to-Market (RM) 1826 and SH 71 to
Silvermine Drive
Travis County, Texas
CSJ: 0113-08-060 and 0700-03-077

December 2016; Revised November 2017, August 2018

General Site Photographs

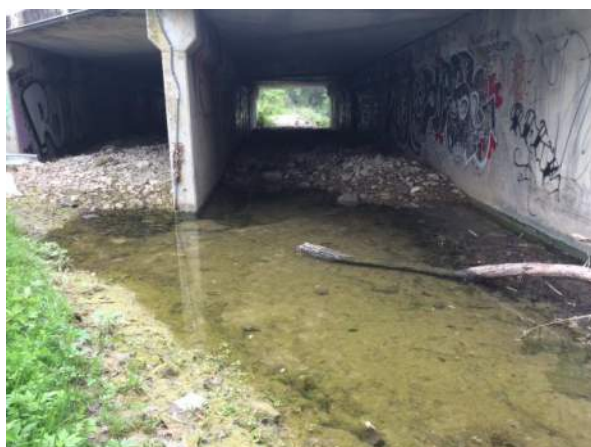
Feature F-1 is a group of widely spaced fractures within the Williamson Creek streambed located just upstream of US290. The orientation of the fractures, N34°E, suggests they may be related to displacement along the Mount Bonnell Fault, which is located a few hundred feet to the northwest. However, these fractures do not appear to be able to convey a significant amount of recharge into the subsurface because fracture apertures are less than one-tenth of one inch and the opposing sides are similar in shape. This suggests that enlargement through dissolution has occurred. As such, there is limited likelihood that recharge occurs through this feature.

Feature F-1. Widely spaced fractures within the Williamson Creek streambed located just upstream of US290

Because of the correspondence of the orientation of these fractures with the orientation of Mount Bonnell Fault, the feature could have a connection to a deeper karst feature in the subsurface. Appropriate precautions should be considered in planning for construction and during construction.

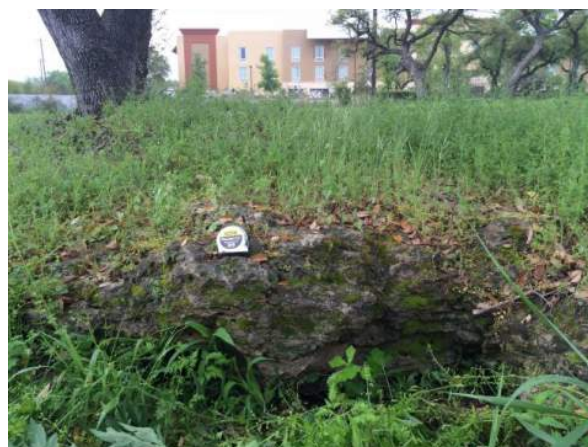
Feature F-2 is a solution cavity situated along the base of a bedding outcrop. The extent of the feature is limited due to infilling by soil and organic debris and animal burrowing is evident. The potential for rapid infiltration is low and the feature was evaluated as non-sensitive.

Feature F-2 solution cavity situated along the base of a bedding outcrop

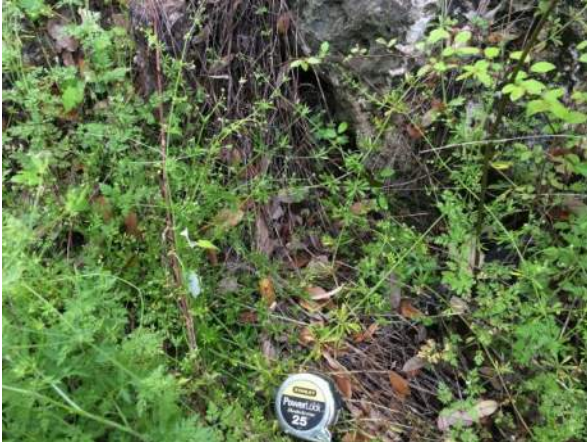
Feature F-2 zoom-in of solution cavity situated along the base of a bedding outcrop

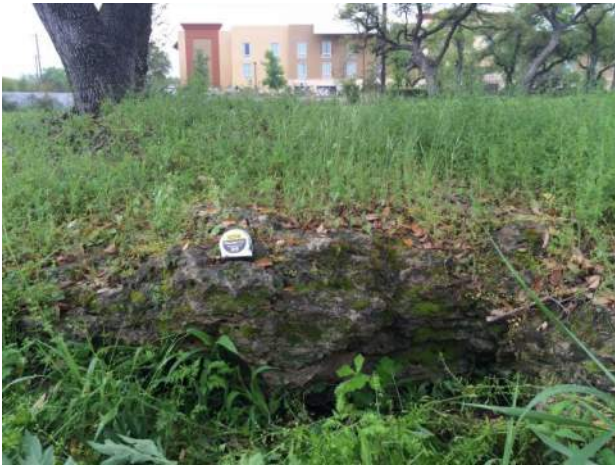
Feature F-4 is zone of fractures located south of US290 along the southern margin of the TxDOT right-of-way. The feature encompasses an approximately 100-ft by 30-ft area on a gently sloping hillside covered with live oak trees and Ashe juniper (locally referred to as cedar). Multiple fractures are present, and apertures appear to show some evidence of solution enlargement although most are infilled with vegetation and soil. While there are slight variations, the average trend of the fractures is about N20°E, which is consistent with the regional structural trend. This suggests the fractures may be related to displacement along the Mount Bonnell Fault to the northwest. The outcrop in which the fractures are present also shows some honeycomb texture that supports the possibility of recharge enhancement through solution enlargement. However, the large amount of vegetative debris filling the fractures, coupled with the Speck soils that are characterized by high runoff potential and occur across this portion of the study area, suggest a rapid runoff potential in lieu of infiltration. Overall, the feature is expected to have a low potential for recharge to the aquifer. However, due to the zone classification of the feature and similarity with the regional structural trend, the feature was evaluated as sensitive.

Feature F-4. Zone of fractures located south of US290 along the southern margin of the TxDOT right-of-way

This feature contains a zone of fractures coincident with the regional structural trend and could have a connection to a deeper karst feature in the subsurface that contributes greater than average recharge to the Edwards Aquifer. Appropriate precautions should be considered in planning for construction and during construction.

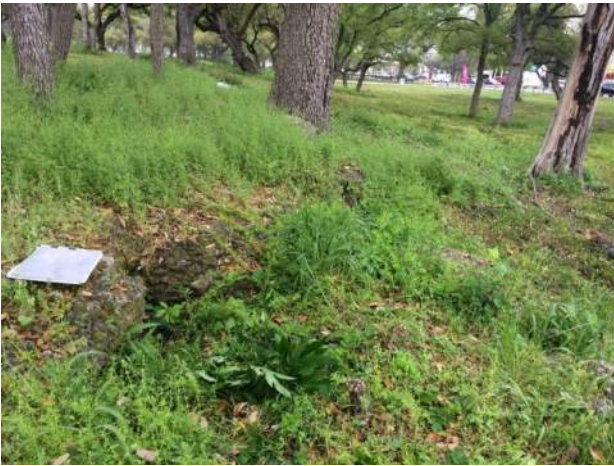
Feature F-4. Zone of fractures looking to the east.

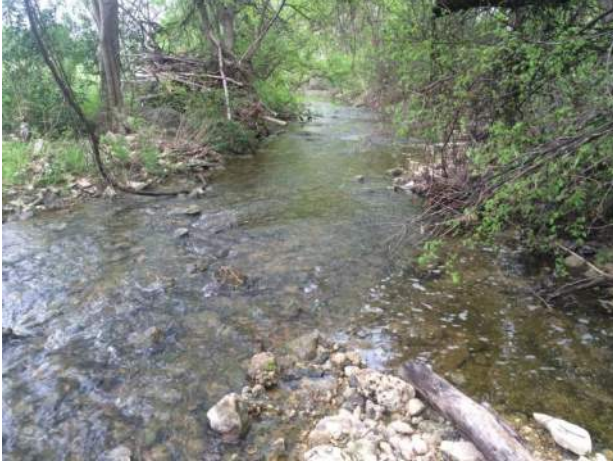
Where exposed within Williamson Creek, the Mount Bonnell Fault shows little evidence of solution enlargement. The location of the feature is based upon nearby fractures and changes in lithology on opposing sides of the fault. The fault juxtaposes the Glen Rose Limestone to the northwest against Edwards Limestone. Most fractures within the streambed appear to be sealed with fine grained sediment and vegetative debris. This feature is not exposed in any other location within the project area. It was evaluated as sensitive with a moderate potential for infiltration.

Feature F-5. Surface expression of the Mount Bonnell Fault within Williamson Creek.

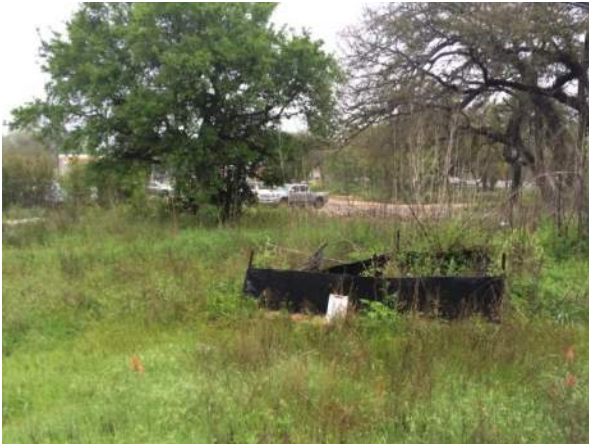
Feature F-6 – solution cavity located along the southern limits of the TxDOT right-of-way south of US290

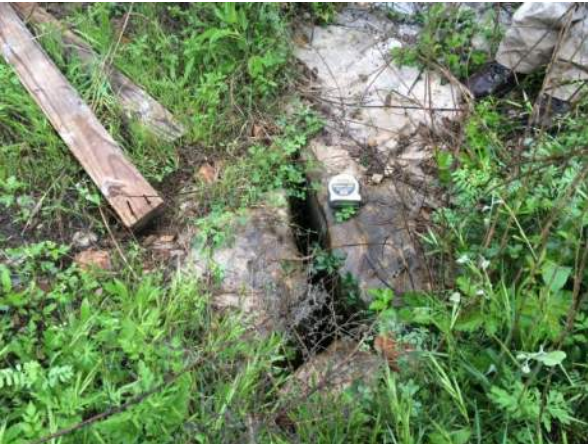
Feature F-6 – solution cavity located along the southern limits of the TxDOT right-of-way south of US290
