Geologic Assessment

U.S. Highway 290 (US 290) / State Highway (SH)
71 West from State Loop 1 (MoPac) to
Ranch-to-Market (RM) 1826 and SH 71 to
Silvermine Drive
Travis County, Texas
CSJ: 0113-08-060 and 0700-03-077

December 2016; Revised November 2017

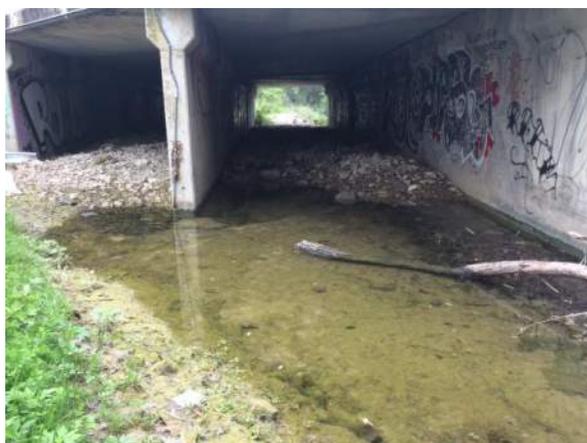
Feature F-1 is a group of widely spaced fractures within the Williamson Creek streambed located just upstream of US290. The orientation of the fractures, N34°E, suggests they may be related to displacement along the Mount Bonnell Fault, which is located a few hundred feet to the northwest. However, these fractures do not appear to be able to convey a significant amount of recharge into the subsurface because fracture apertures are less than one-tenth of one inch and the opposing sides are similar in shape. This suggests that enlargement through dissolution has occurred. As such, there is limited likelihood that recharge occurs through this feature.

Feature F-1. Widely spaced fractures within the Williamson Creek streambed located just upstream of US290

Because of the correspondence of the orientation of these fractures with the orientation of Mount Bonnell Fault, the feature could have a connection to a deeper karst feature in the subsurface. Appropriate precautions should be considered in planning for construction and during construction.

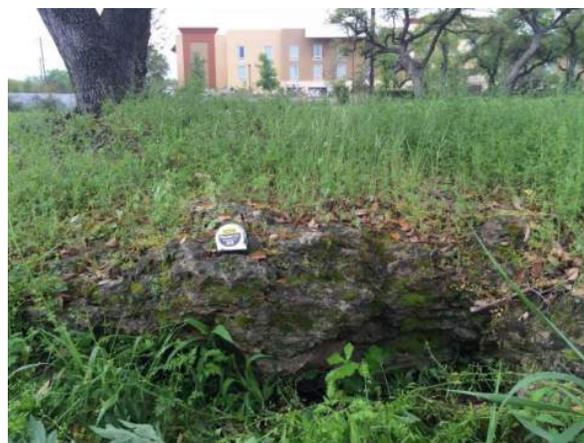
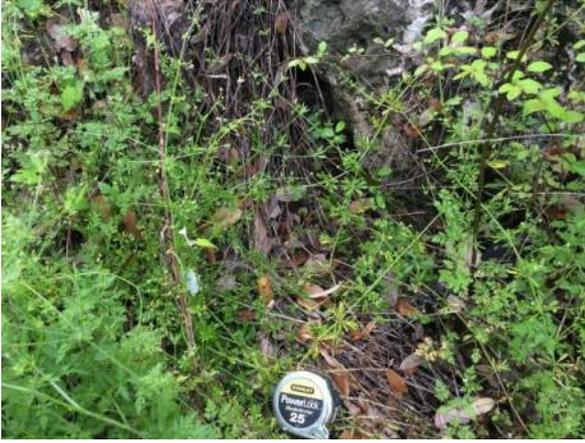
Feature F-2 is a solution cavity situated along the base of a bedding outcrop. The extent of the feature is limited due to infilling by soil and organic debris and animal burrowing is evident. The potential for rapid infiltration is low and the feature was evaluated as non-sensitive.

Feature F-2 solution cavity situated along the base of a bedding outcrop

Feature F-2 zoom-in of solution cavity situated along the base of a bedding outcrop

This feature likely does not have a strong connection to a deeper karst feature in the subsurface. Appropriate precautions should be considered in planning for construction and during construction.

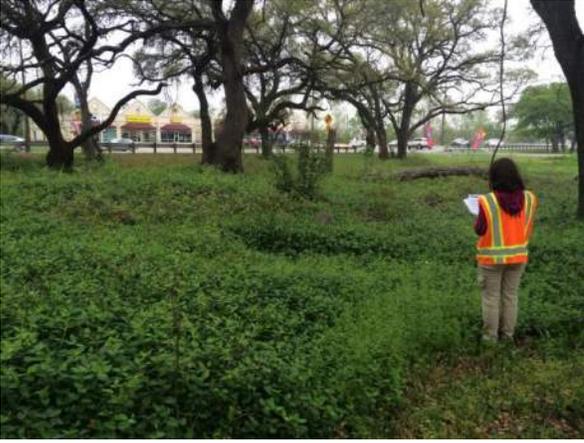
Feature F-3 is a small outcrop of limestone on the south side of US290 exhibiting small interconnected solution enlarged cavities. This type of feature, commonly referred to as a "honeycomb" texture, suggests the outcrop may at one time have been exposed to significant groundwater flow. It is positioned along a small drainage paralleling US290, however no water was present in the drainage, and it appears that surface flow is only present during significant precipitation events. Natural vegetation, plant debris, and high runoff potential soils

appear to cover most of the area. These factors limit infiltration while supporting rapid runoff. The feature was evaluated as non-sensitive with a low relative potential for infiltration.

Feature F-3 small outcrop of limestone on the south side of US290 exhibiting small interconnected solution enlarged cavities (Depression, veg cover)

This feature likely does not exhibit high infiltration and recharge to the subsurface. Appropriate precautions should be considered in planning for construction and during construction.

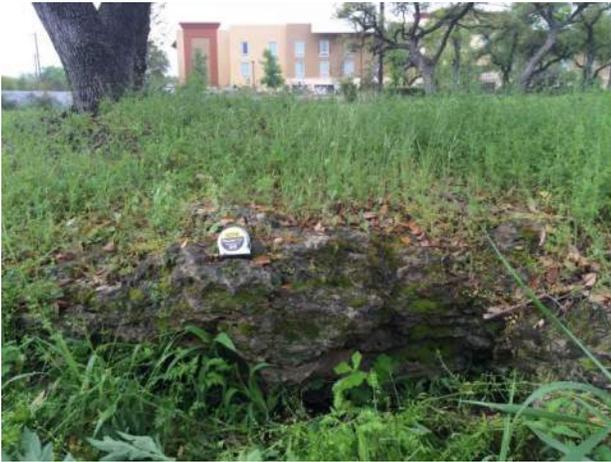
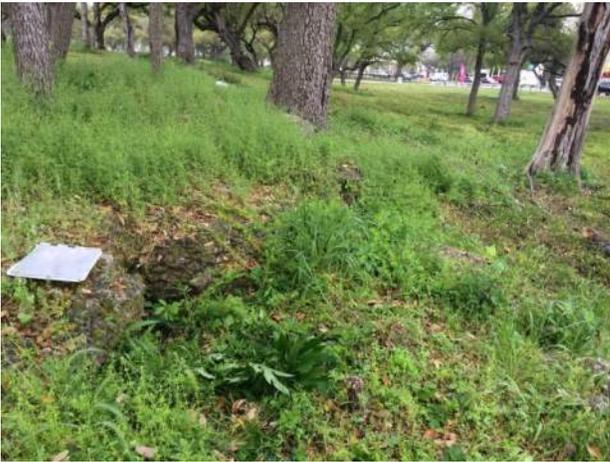
Feature F-4 is zone of fractures located south of US290 along the southern margin of the TxDOT right-of-way. The feature encompasses an approximately 100-ft by 30-ft area on a gently sloping hillside covered with live oak trees and Ashe juniper (locally referred to as cedar). Multiple fractures are present, and apertures appear to show some evidence of solution enlargement although most are infilled with vegetation and soil. While there are slight variations, the average trend of the fractures is about N20°E, which is consistent with the regional structural trend. This suggests the fractures may be related to displacement along the Mount Bonnell Fault to the northwest. The outcrop in which the fractures are present also shows some honeycomb texture that supports the possibility of recharge enhancement through solution enlargement. However, the large amount of vegetative debris filling the fractures, coupled with the Speck soils that are characterized by high runoff potential and occur across this portion of the study area, suggest a rapid runoff potential in lieu of infiltration. Overall, the feature is expected to have a low potential for recharge to the aquifer. However, due to the zone classification of the feature and similarity with the regional structural trend, the feature was evaluated as sensitive.

Feature F-4. Zone of fractures located south of US290 along the southern margin of the TxDOT right-of-way

Feature F-4. Zone of fractures looking to the east.

This feature contains a zone of fractures coincident with the regional structural trend and could have a connection to a deeper karst feature in the subsurface that contributes greater than average recharge to the Edwards Aquifer. Appropriate precautions should be considered in planning for construction and during construction.

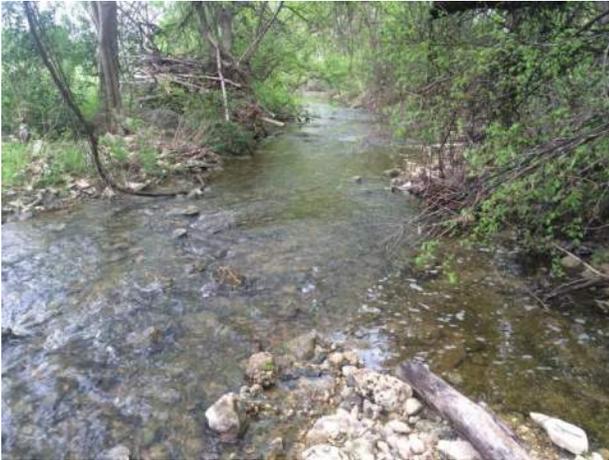
Where exposed within Williamson Creek, the Mount Bonnell Fault shows little evidence of solution enlargement. The location of the feature is based upon nearby fractures and changes in lithology on opposing sides of the fault. The fault juxtaposes the Glen Rose Limestone to the northwest against Edwards Limestone. Most fractures within the streambed appear to be sealed with fine grained sediment and vegetative debris. This feature is not exposed in any other location within the project area. It was evaluated as sensitive with a moderate potential for infiltration.

Feature F-5. Surface expression of the Mount Bonnell Fault within Williamson Creek.

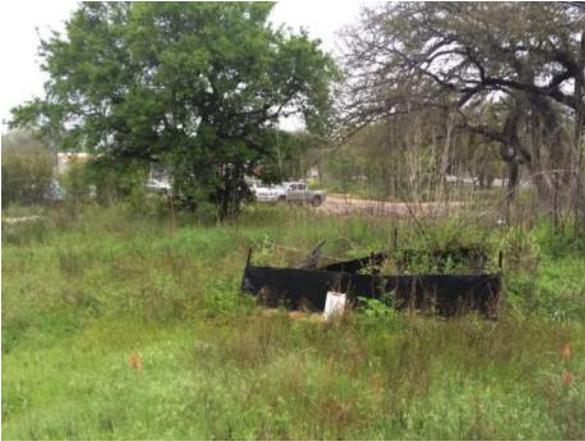
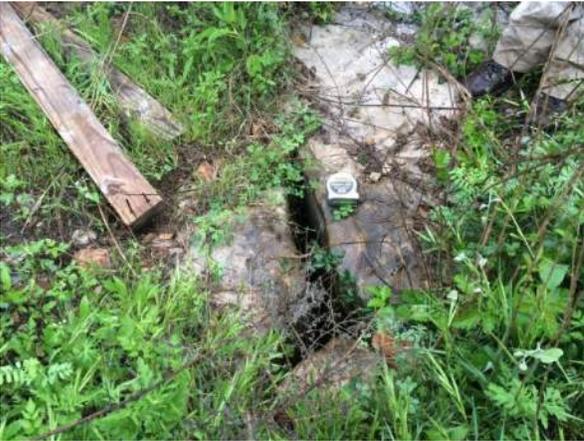
Feature F-6 – solution cavity located along the southern limits of the TxDOT right-of-way south of US290
